# AAIB Bulletin S1/2019

## *SPECIAL*

### ACCIDENT

<b>Aircraft Type and Registration:</b>	Piper PA-46-310P Malibu, N264DB
<b>No &amp; Type of Engines:</b>	1 Teledyne Continental TSIO-520-BE engine
<b>Year of Manufacture:</b>	1984 (Serial no: 46-8408037)
<b>Date &amp; Time (UTC):</b>	21 January 2019 at 2016 hrs
<b>Location:</b>	22 nm north-north-west of Guernsey
<b>Type of Flight:</b>	Unknown
<b>Persons on Board:</b>	Crew - 1                      Passengers - 1
<b>Injuries:</b>	Crew - 1 (Missing)      Passengers - 1 (Fatal)
<b>Nature of Damage:</b>	Aircraft destroyed
<b>Commander's Licence:</b>	Private Pilot's Licence
<b>Commander's Age:</b>	59 years
<b>Commander's Flying Experience:</b>	Approximately 3,700 hours Last 90 days - unknown Last 28 days - unknown
<b>Information Source:</b>	AAIB Field Investigation

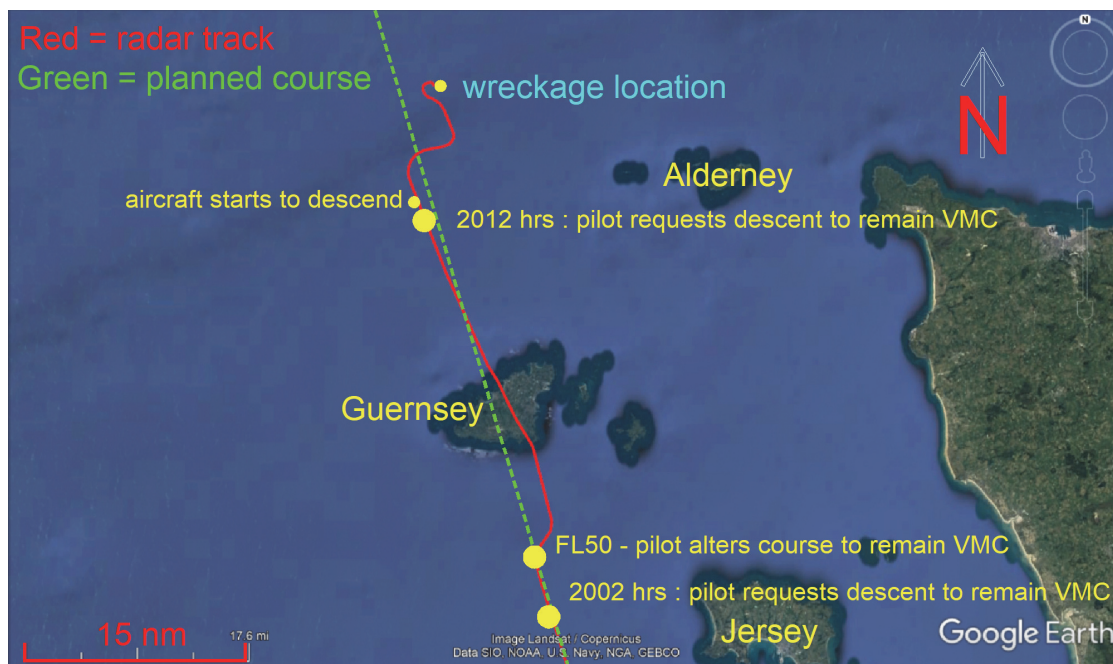
**Figure 3**

The aircraft flew on its planned route towards Cardiff until it was approximately 13 nm south of Guernsey when the pilot requested and was given a descent to remain in Visual Meteorological Conditions (VMC)<sup>3</sup>. Figure 3 shows the aircraft's subsequent track. The last radio contact with the aircraft was with Jersey Radar at 2012 hrs, when the pilot asked for a further descent. The aircraft's last recorded secondary radar point was at 2016:34 hrs, although two further primary returns were recorded after this<sup>4</sup>. The wreckage of N264DB was subsequently found on the seabed about 30 metres from the position of the last secondary radar point recorded by the radar at Guernsey.

Aircraft track in the vicinity of Guernsey

At 2002:10 hrs, N264DB was about 11 nm west of Jersey and 13 nm south of Guernsey when the pilot requested clearance to descend to “MAINTAIN VMC” (Figure 3). The aircraft was cleared to FL50, with the instruction to advise ATC if a further descent was required. Shortly afterwards, the aircraft began to descend whilst also making a right turn followed by a left turn. This positioned the aircraft overhead Guernsey, about 1.5 nm parallel to the planned track. The controller then inquired if N264DB required a further descent, to which the pilot responded: “NEGATIVE, JUST AVOIDED A PATCH THERE, BUT BACK ON HEADING FIVE THOUSAND FEET”.

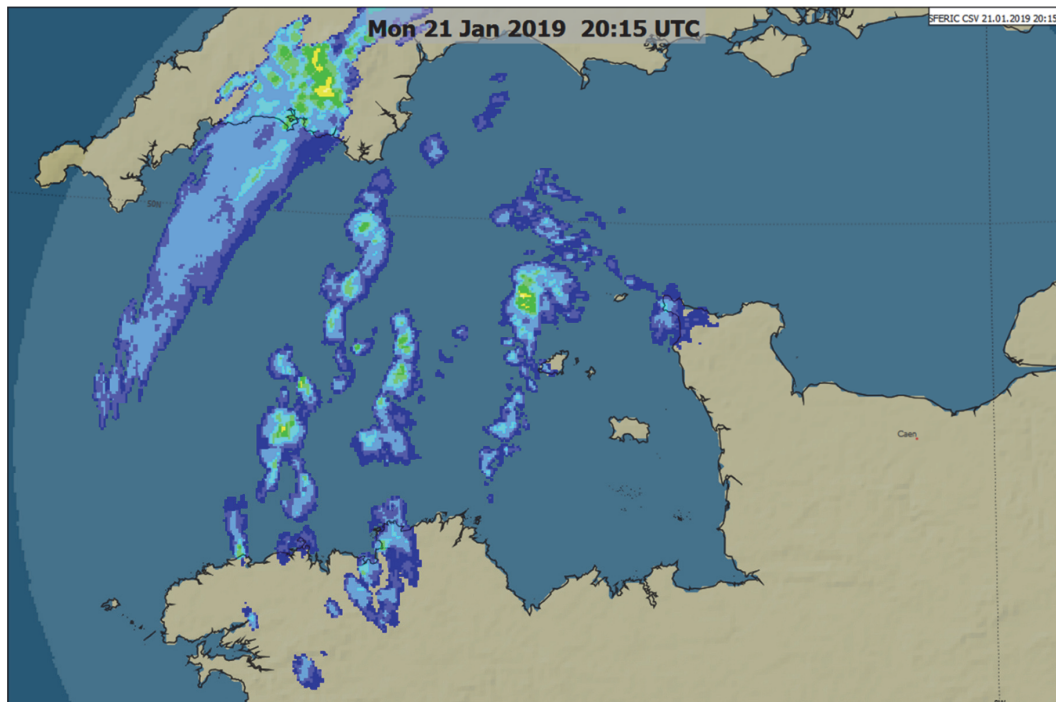
**Figure 4**

The rainfall radar picture at 2015 hrs showed a band of showers, some heavy, passing through the area of flight as shown in Figure 4.

Rainfall radar for 2015 hrs

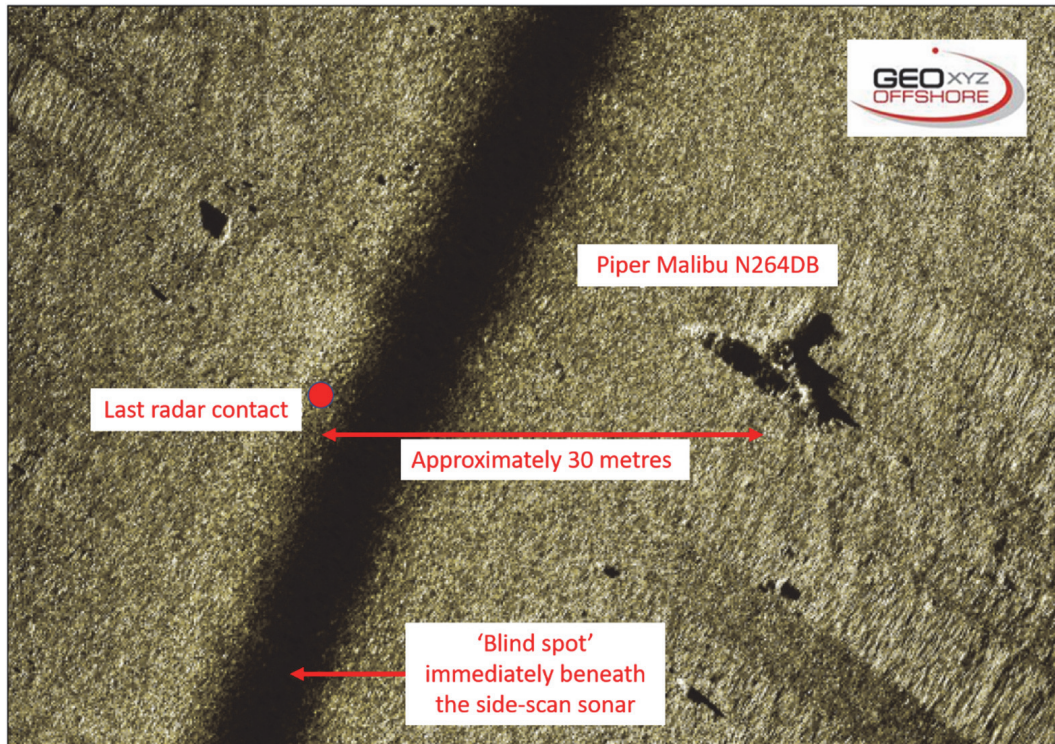
**Figure 6**

Both vessels began their side-scan survey of the seabed on the morning of Sunday, 3 February 2019. Early in the search, the FPV Morven identified an object of interest at a depth of approximately 68 m and cleared the immediate area to allow the Geo Ocean III to launch its ROV and examine the object, which was identified as the missing aircraft. Figure 6 shows a side-scan sonar image taken from the Geo Ocean III.

Side-scan sonar image of N264DB

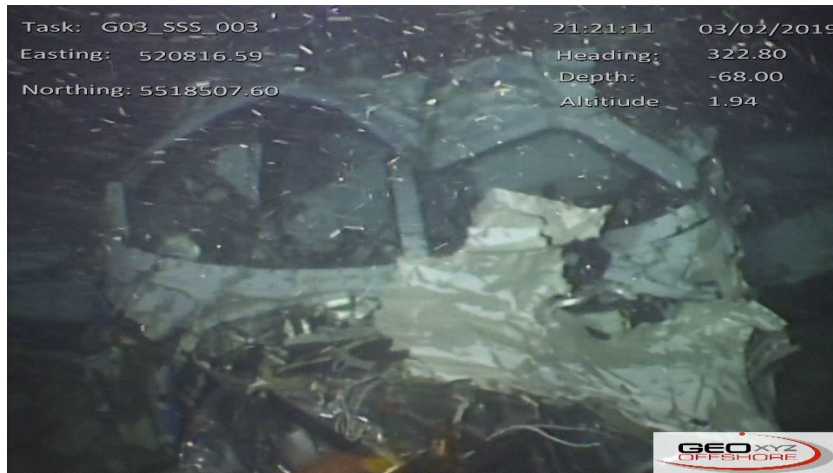
**Figure 7**

From the ROV video examination it was possible to establish that the aircraft was extensively damaged, and the main body of the aircraft was in three parts held together by electrical and flying control cables. The engine had disconnected from the cockpit area, and the rear section of the fuselage had broken away from the forward section adjacent to the trailing edge of the wing. The outboard section of both wings, tail plane and fin were missing. Figures 7 to 9 show images taken by the ROV.

View looking at windscreen and cockpit area

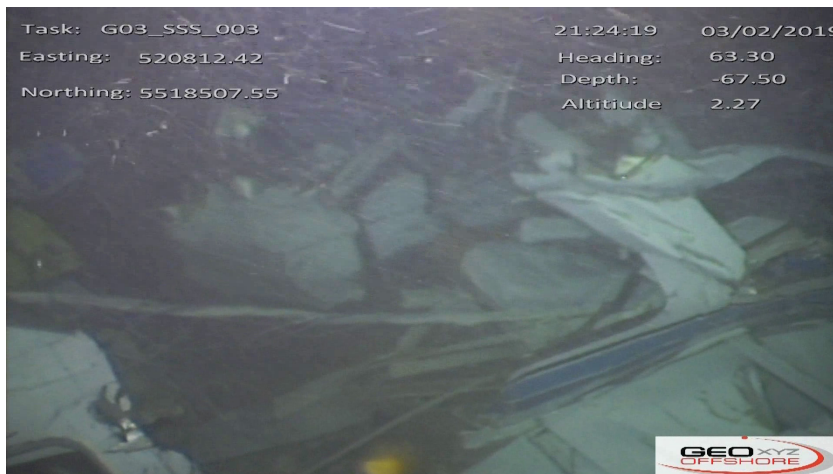
**Figure 8**

View looking at cabin and break in fuselage

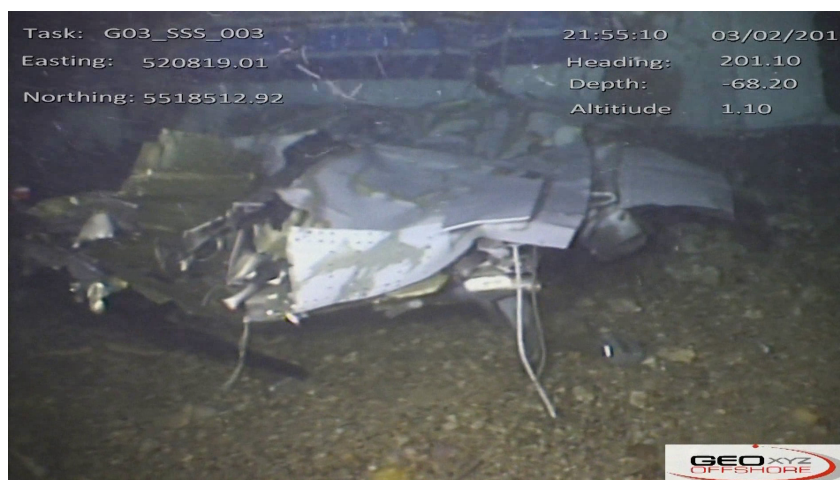
**Figure 9**

View looking at remains of inner wing

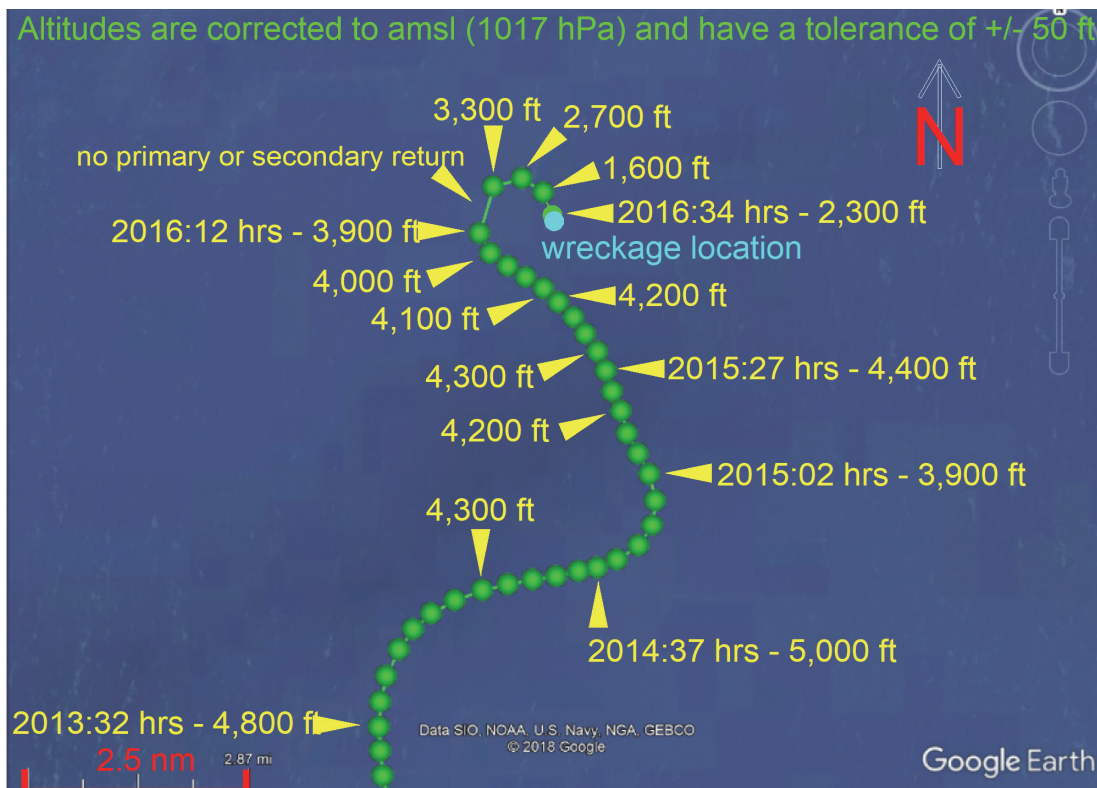
**Figure 10**

N264DB started to descend gradually and turned onto a track of about 060°T (Figure 10). Approximately 30 seconds later the aircraft turned left onto about 305°T. During this sequence of turns the aircraft descended from about 4,800 ft to 4,300 ft, climbed to about 5,000 ft, and then descended again to about 3,900 ft. The aircraft then proceeded to climb to about 4,200 ft on a track that was nearly parallel with the planned course of 343°T. Its average groundspeed was about 175 kt.

Radar track of final section of flight  
(created from a combination of data from Jersey (Les Platons) and Guernsey radars)

At about 2015:30 hrs, N264DB started to make a gradual left turn, which was followed at about 2016:10 hrs by a right turn of approximately 180°. During this turn, data from two independent radars (Guernsey and Jersey<sup>12</sup>) showed the aircraft descend to an altitude of about 1,600 ft at an average rate of approximately 7,000 ft/min. A few seconds later (at 2016:34 hrs) the final secondary radar return was recorded, which indicated that the aircraft may have climbed rapidly to about 2,300 ft. Two more primary radar returns were recorded, timed at 2016:38 hrs and 2016:50 hrs respectively, but it is not yet known whether they represent valid returns from the aircraft.
