AIRWORTHINESS DIRECTIVE	
Date: 12-18-2024	DA RA N° 2024- 05-01 R1	
<p>THIS AIRWORTHINESS DIRECTIVE, DEVELOPED AND ISSUED BY THE AERONAUTICAL CERTIFICATION DEPARTMENT, OFFICE OF AIRWORTHINESS, PURSUANT TO THE PROVISIONS OF ACT N.º 17285, AERONAUTICAL CODE OF THE REPUBLIC OF ARGENTINA, AND PUBLISHED IN THE OFFICIAL GAZETTE ON MAY 23, 1957 CONTAINING THE MODIFICATIONS SUBSEQUENTLY ADDED AND AIRWORTHINESS REGULATIONS, DNAR PART 39, IS APPLICABLE TO ALL AIRCRAFT OF THE SAME MAKE AND MODEL REGISTERED IN THE NATIONAL AIRCRAFT REGISTRY. AN AIRCRAFT TO WHICH A DA IS APPLICABLE MAY NOT BE OPERATED EXCEPT IN ACCORDANCE WITH THE REQUIREMENTS OF SAID DA.</p>		
APPLICABILITY		
Manufacturer LAVIA SA	Aircraft Type-Model PA25 / PA25-235 / PA25-260, INCLUDING AIRCRAFT MANUFACTURED BY PIPER, CHINCUL, LAVIASA and FAdE SA	
Revision	Revision 1	
Superseded document	This Airworthiness Directive supersedes DA RA N° 2024-05-01, Original Revision.

Reason for revision	The purpose of this revision is to incorporate instructions under APPENDIX 1 to conduct an Eddy Current NDT Inspection in specific areas of the PA-25 front wing spar, to comply with item 2b) of this Airworthiness Directive.	
Subject	Corrosion f

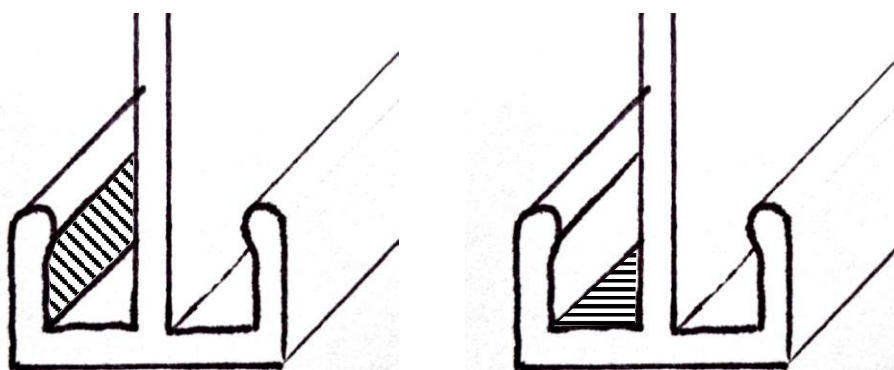
Figure 1 – Inspection areas of the PA-25 front spar

(1) The specific upper/lower spar flange areas to be inspected are shown in **Figure 1** below.

Area 1: Front spar cap flange,
leading edge fitting area

Area 2: Inside of spar cap

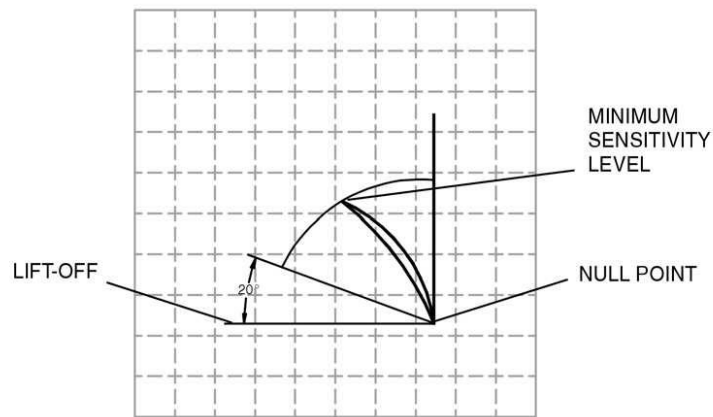
Figure 4D – Type Lift-off Response Signal

- A. Place the surface probe on the reference standard in an area away from the notches (cracks simulated by EDM-Electrical Discharge Machining). Use reference standards as shown in **Table 2**, paragraph 4.
- B. Determine the null point.
- C. Lift the surface probe from the reference standard used and check the equipment display to view the lift-off response.
- D. Adjust the equipment until the lift-off response is in a horizontal position and to the left of the null point, providing similar responses to those shown in **Figure 4D**.

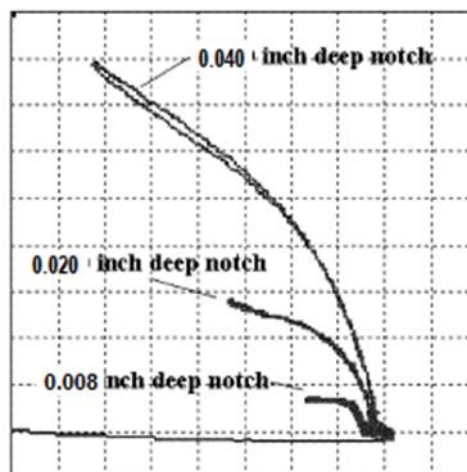
Figure 4E –Type Sensitivity Verification Signal (aluminum)

- E. Check now the sensitivity of the inspection configuration by placing the probe on the **RS0824-2024T3** standard by means of a non-conducting belt in the standard (if needed), scan the **0,008 in**, **0,020 in** and **0,040 in** deep reference notches. Responses should be like those of **Figure 4E**.

NOTE: A 0,005-notch response should produce a minimum of FSH 5% in a vertical response (half of a grid division) and be clearly differentiated from the reference noise.

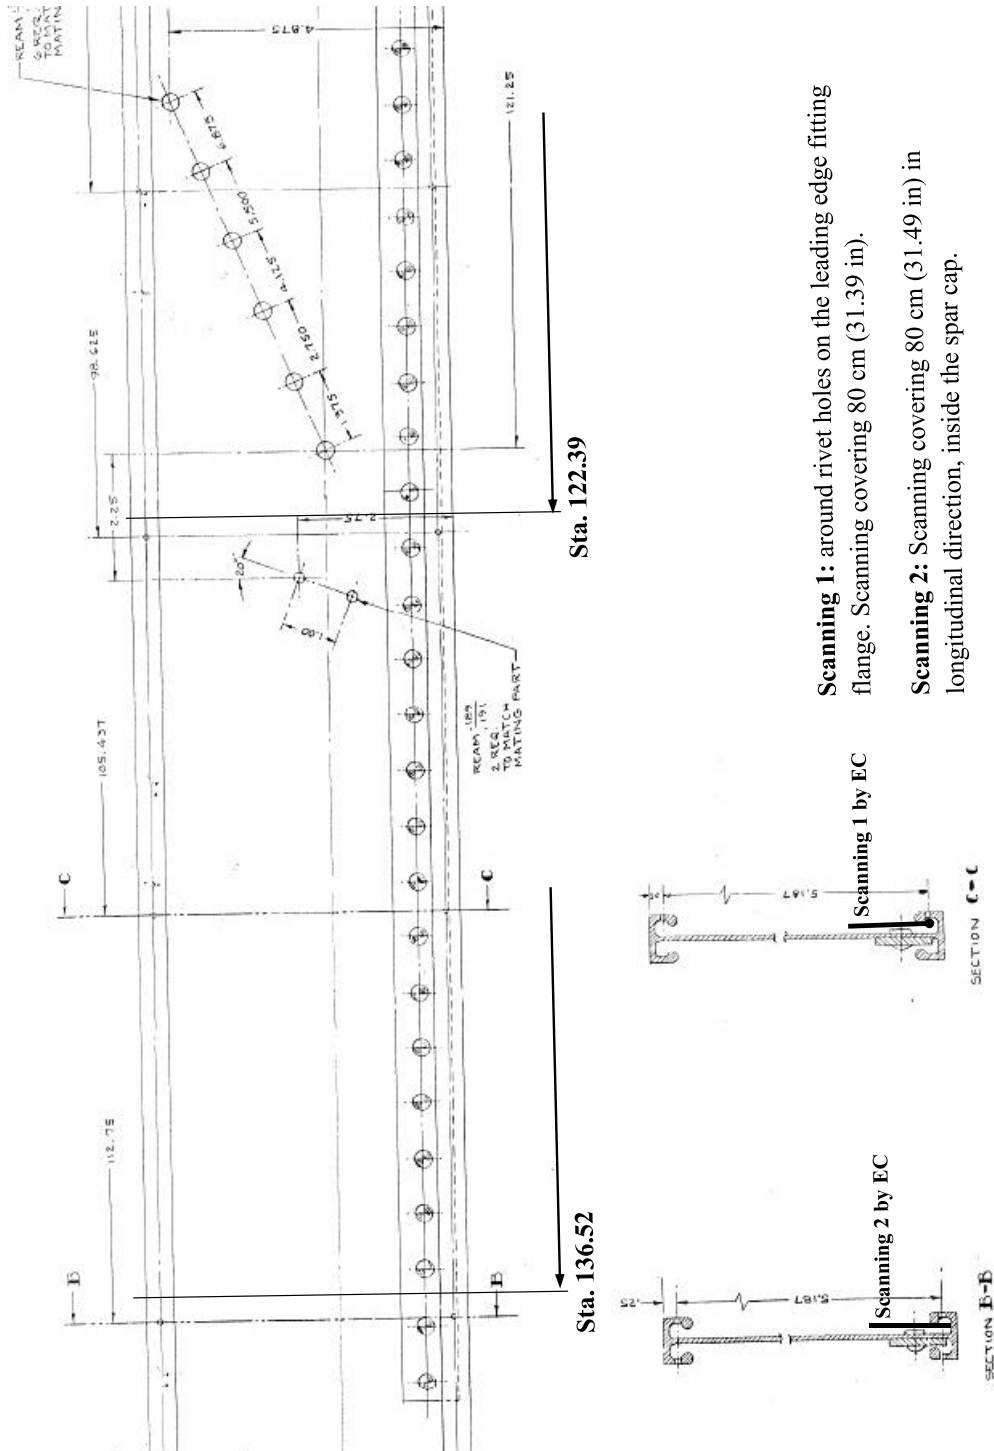
Figure 7D – Spar Caps Location (Cont.)

The first scanning must be performed by accessing **inspection access covers N.º 1 and N.º 2** by placing the SPO-3611 probe or equivalent on the inside of the **upper spar cap flange** and by accessing **inspection access cover N.º 6** by placing the SPO-3611 probe or equivalent on the inside of the **lower spar cap flange** over the entire length and between adjacent ribs, particularly on the edges of the existing holes.

The second scanning must be performed by accessing inspection access covers N.º 1 and N.º 2 over the entire length and between adjacent ribs by placing the TPEN9100-6 probe or equivalent on the inside basis of the **upper spar cap** and by accessing **inspection access cover N.º 6** over the entire length and between adjacent ribs by placing the TPENFLX-6 probe or equivalent on the inside basis of the **lower spar cap**.

Scanning 1: around rivet holes on the leading edge fitting flange. Scanning covering 80 cm (31.39 in).

Scanning 2: Scanning covering 80 cm (31.49 in) in longitudinal direction, inside the spar cap.

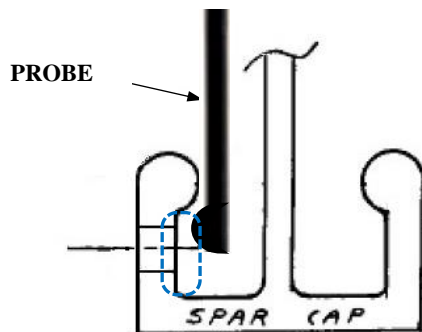
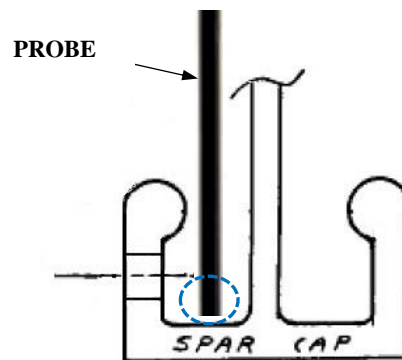
Figure 7E –Inspection areas and scanning

- E. The actual scanning of the areas to be inspected, as shown in **Figure 7E**, should cover 80 cm (31.49 in) especially around the holes, gouges, scratches and dents, and corrosion pits.

Scanning 1: around rivet holes on the leading edge fitting flange. Scanning covering 80 cm (31.39 in).

Scanning 2: Scanning covering 80 cm (31.49 in) in longitudinal direction, inside the spar cap.
