# AAIB Bulletin S1/2019

## *SPECIAL*

### ACCIDENT

<b>Aircraft Type and Registration:</b>	Piper PA-46-310P Malibu, N264DB
<b>No &amp; Type of Engines:</b>	1 Teledyne Continental TSIO-520-BE engine
<b>Year of Manufacture:</b>	1984 (Serial no: 46-8408037)
<b>Date &amp; Time (UTC):</b>	21 January 2019 at 2016 hrs
<b>Location:</b>	22 nm north-north-west of Guernsey
<b>Type of Flight:</b>	Unknown
<b>Persons on Board:</b>	Crew - 1                      Passengers - 1
<b>Injuries:</b>	Crew - 1 (Missing)      Passengers - 1 (Fatal)
<b>Nature of Damage:</b>	Aircraft destroyed
<b>Commander's Licence:</b>	Private Pilot's Licence
<b>Commander's Age:</b>	59 years
<b>Commander's Flying Experience:</b>	Approximately 3,700 hours Last 90 days - unknown Last 28 days - unknown
<b>Information Source:</b>	AAIB Field Investigation

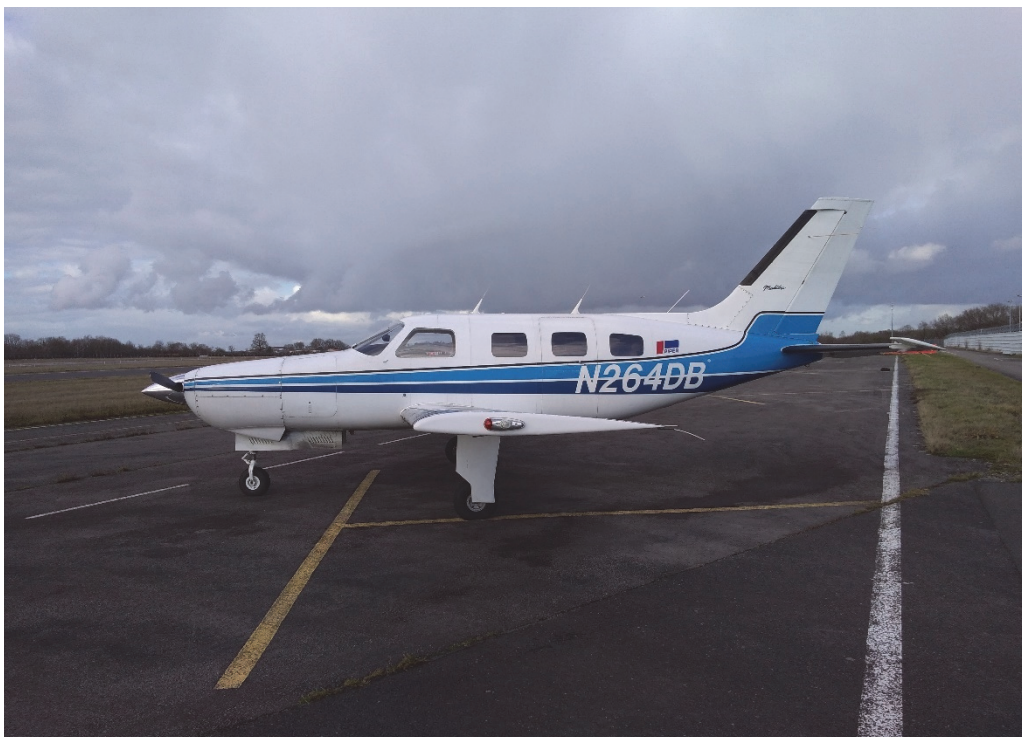
**Figure 1**

N264DB on the ground at Nantes prior to the flight

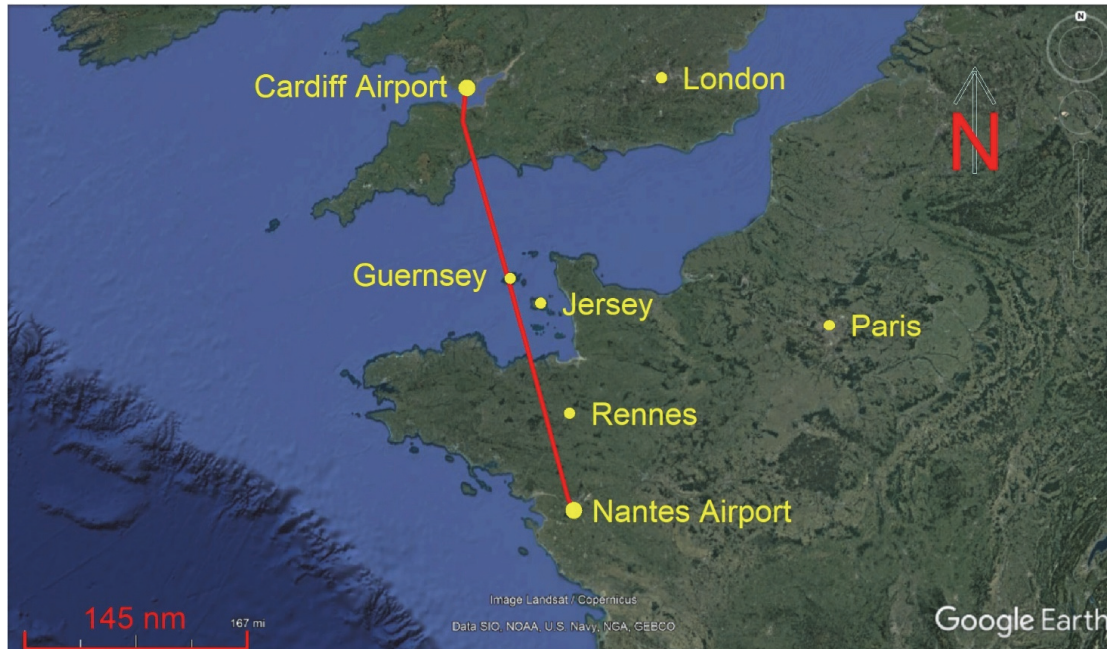
**Figure 2**

The pilot's planned route would take the aircraft on an almost direct track from Nantes to Cardiff, flying overhead Guernsey en route (Figure 2). The Visual Flight Rules (VFR) flight plan indicated a cruise altitude of 6,000 ft amsl<sup>2</sup> and a distance of 265 nm.

Planned route from Nantes to Cardiff

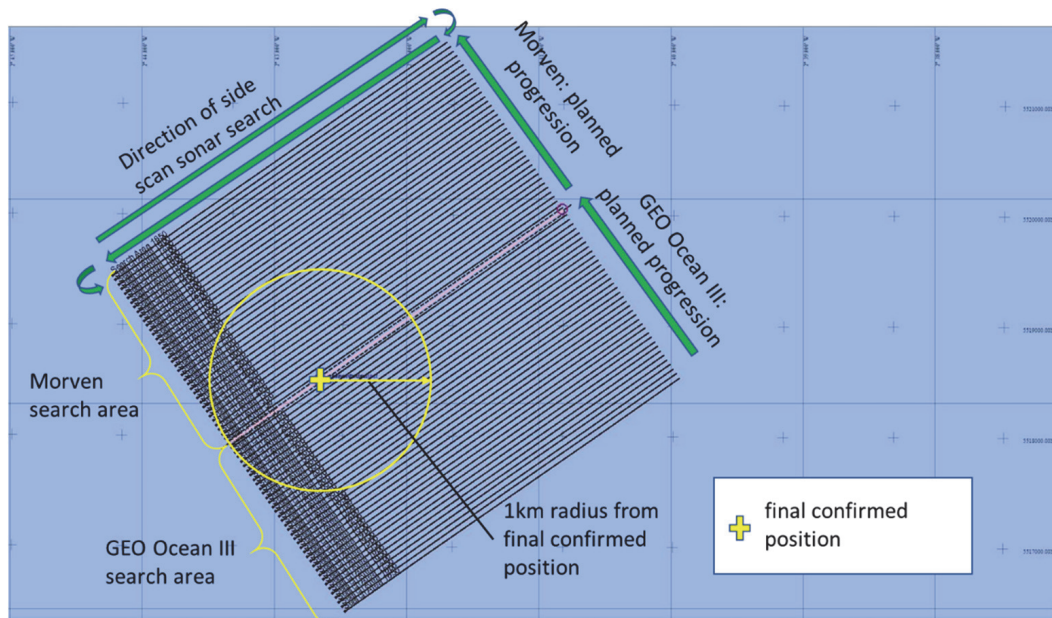
**Figure 5**

interest. The second phase would be an examination of those objects when the tidal flow allowed<sup>7</sup> using the camera on a Remotely Operated Vehicle (ROV) deployed from the Geo Ocean III. To ensure safe separation between the vessels and towed sensors, and to maximise the efficiency of the search, the area was split into two parts and each vessel was allocated one part (Figure 5).
